816-X Motor Mounting Nuts

Operator Model(s): 816-X

Issue Date: 10/30/2019

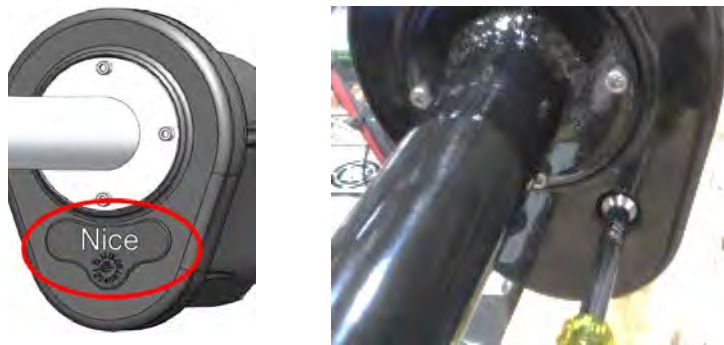
FIGURE 1: Motor Mount Nut Locations on 816-X actuator

Issue: Motor mounting nuts may not be correctly torqued. We have investigated and identified a group of actuators that may have shipped with this condition. See details below.

This will not result in the malfunction of the actuator but may shorten its lifespan. Our recommendations at this time is to confirm the tightness of the 2ea 10-32 nuts located under the "Nice" logo during installation. Torque should be approximately 80 inch lbs. If the nuts are found to be loose, attempt to tighten them with a nut driver. If that is unsuccessful remove the bolts holding the housing in place and provide support to the motor while tightening.
