## Mercury 310 Tactile Buttons Sticking

**APPLIES TO:** Mercury 310 Control Boards  
(applies only to board with PCB serial numbers TSI21250250 to TSI21250490).

**DATE:** 11/19/2021

**SUBJECT:** Mercury 310 buttons sticking when depressed.

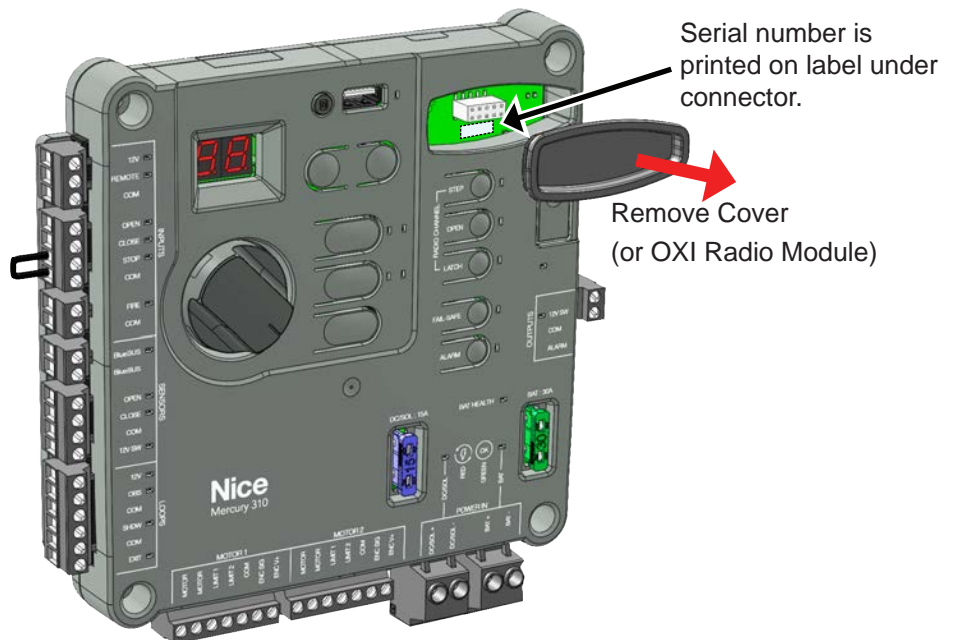
**FIG-1: Mercury 310 Control Board Serial Number Location**

The PCB serial number for the Mercury 310 control boards can be found printed on a label affixed under the OXI radio module connector, and is accessed by removing the OXI slot cover or the OXI radio module (whichever is installed). See FIG-1.

Additionally, if the Control Board serial number falls within the affected range, you may return the control board for a pro-active replacement. Unfortunately, due to global supply constraints, replacement times may be extended. Standard shipping rates will apply. See FIG-1 and note below to access the PCB serial number.
